Manhole Inspection Summary

Manhole # S13EE2026MH

Insp Date: **10/24/06 2:17 PM**

Location Address: **2118 WESTERN RUN DR**

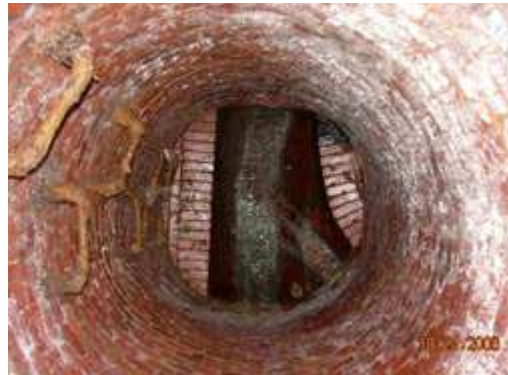
Top View

Evidence of surcharge. Corroded steps.

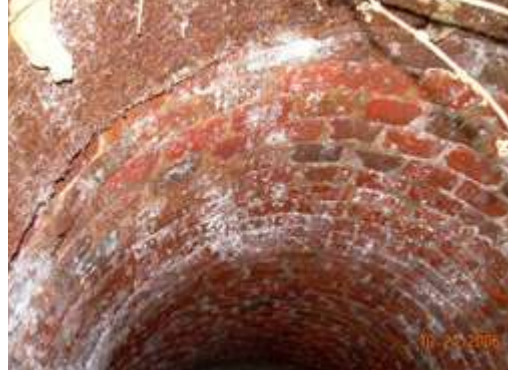
Defect

Frame Leaks. Adjustment deterioration and infiltration.

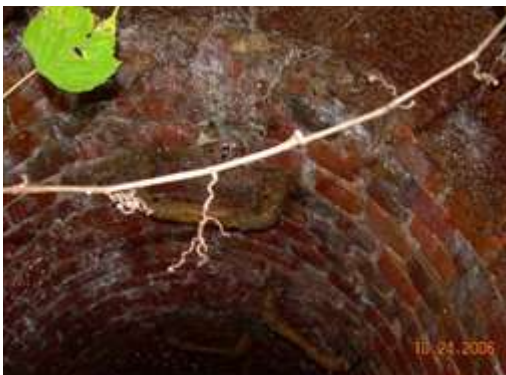
Defect

Adjustment infiltration.

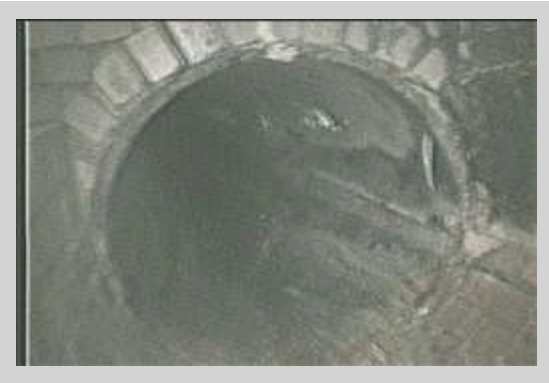
24 in. Circular Gravity Sewer Pipe Out @ 12 O'Clock

Infiltration: **Evidence** Pipe Seal Cond: **Cracked**

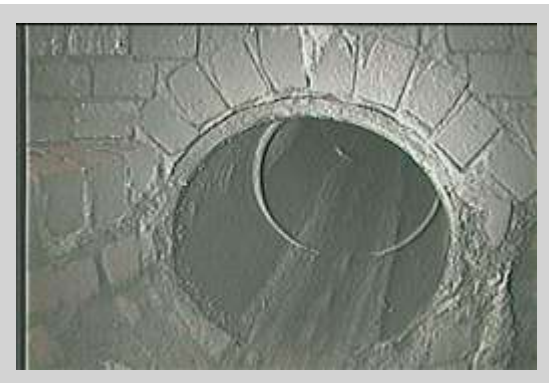
15 in. Circular Gravity Sewer Pipe In @ 5 O'Clock

Deposits: ☐ None ☐ Mud ☐ Sludge ☐ Debris ☒ Grease

Infiltration: **Evidence** Pipe Seal Cond: **Unknown**

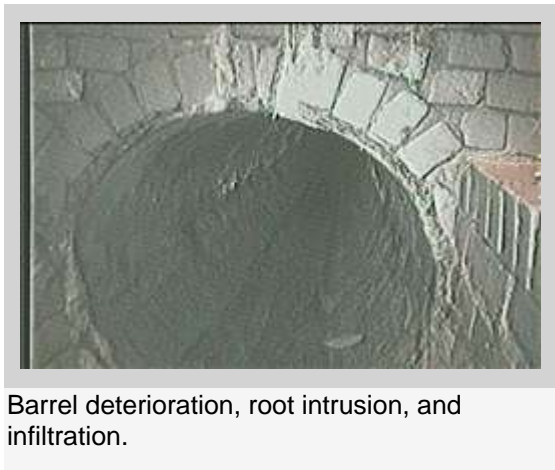
24 in. Circular Gravity Sewer
Pipe In @ 6 O'Clock

Barrel deterioration, root intrusion, and infiltration.

Infiltration: **Evidence** Pipe Seal Cond: **Unknown**
